THE
ÖRSERUMSVIKEN
PROJECT - DECONTAMINATION

Örserumsviken transformed

This publication tells the story of how Örserumsviken, the bay outside Västervik, was transformed from a badly polluted arm of the sea to a reborn, pristine habitat as part of the national campaign for a non-toxic environment.

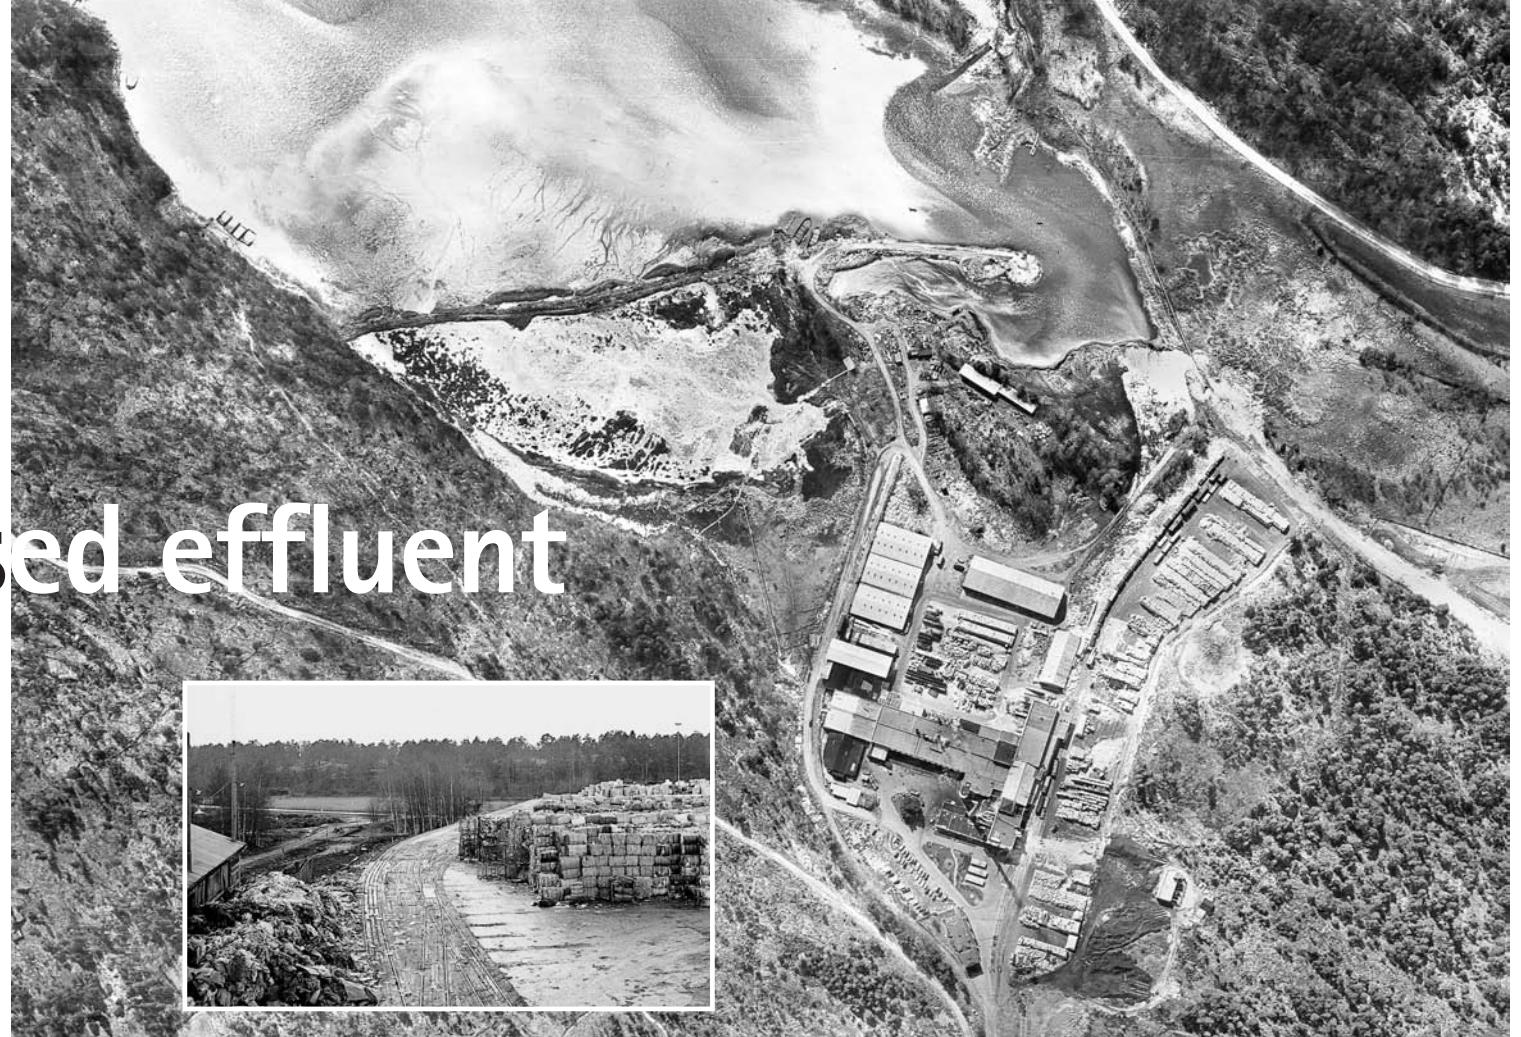
This 1960s air photo shows the papermill area and the inner part of the heavily polluted Örserumsviken. Insert: a picture of the scrap paper depot.

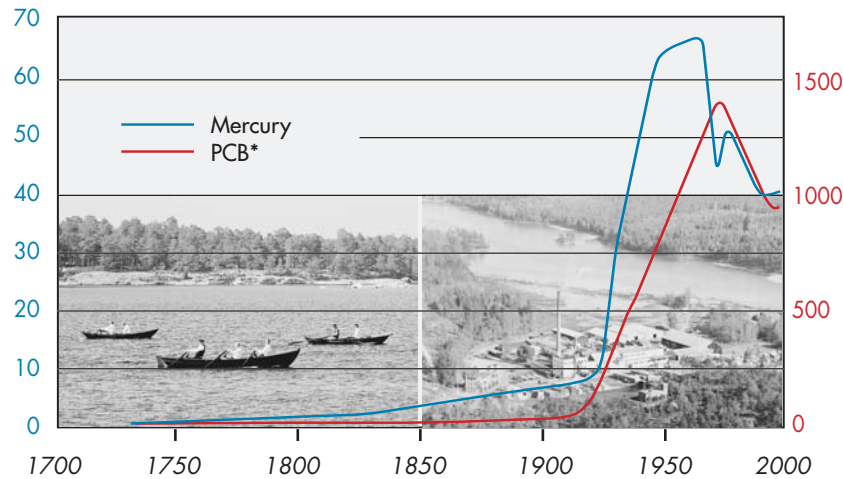
PCB and mercury in the bottom sediment of Örserumsviken

Industrialisation triggered an accumulation of ecotoxins in the environment. The PCB and mercury concentrations in the above diagram are given in nanograms per gram of total solids, but with different scales for the two substances. The visible growth of concentrations already from the 1920s onwards, is due to a certain remixing in the sediments.

* The study included five types of PCB, which means that concentrations of all known types taken together are roughly four times greater.

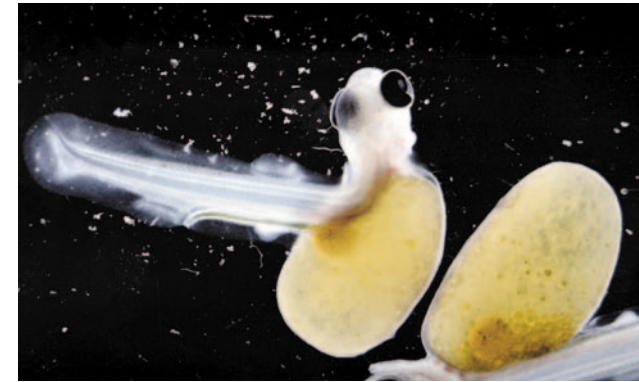
Laboratory experiments showed water from Örserumsviken to cause deformities and increased mortality among fish fry. This picture shows fry with spinal deformities.

When fish fry in a laboratory environment were exposed to water from Örserumsviken, deformities and increased mortality resulted. Studies in the Emån river and elsewhere have yielded similar results, and PAHs are suspected as part of the reason for some fish species having difficulty in reproducing in certain areas along the east coast of Sweden. How did Örserumsviken come to contain such large amounts of PAH, probably something like 550 kilos? Studies of the bay and of the archipelago beyond revealed much heavier PAH concentrations in the bay,

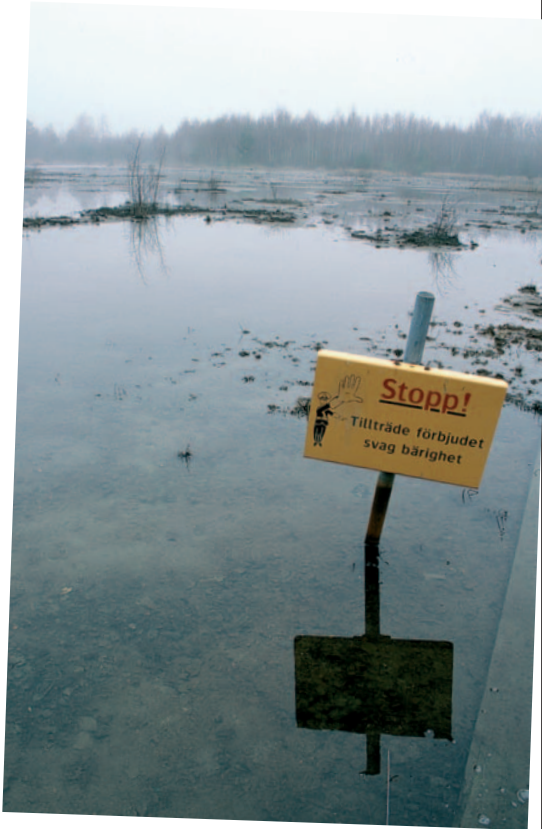
Thus far but no further. Entering the fibre tank at the papermill could have fatal consequences.

The old tank at the papermill contained a morass, several metres thick, of paper fibres from the whole of the papermill's productive career and from the 1978-1979 clean-up.

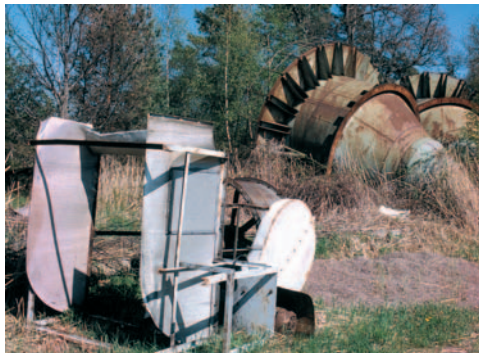
Some of the equipment used for the first clean-up operation was still lying around in 1998.

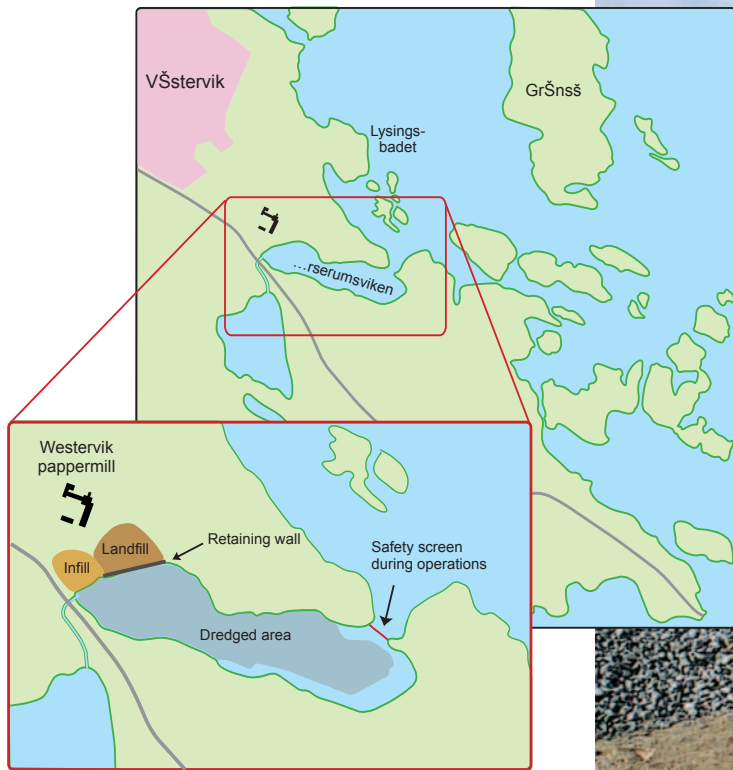
The landfill site built up for the new clean-up operation was covered with bentonite, plastic film, sand and gravel.

The clean-up operation which started in Västervik in the summer of 2001 was the biggest Sweden had ever seen. Work began with the construction of a stout new retaining wall, five metres high and completely impervious, out towards Örsörumsviken, at the same time as the bay was cordoned off with a textile screen to trap the particles present in the water. A control station was also established outside the screen, to ensure that no ecotoxins escaped into the bay.

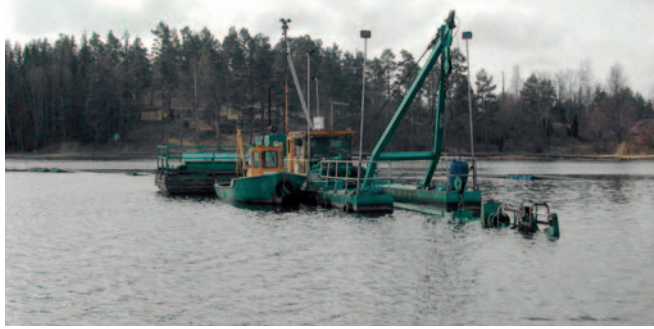
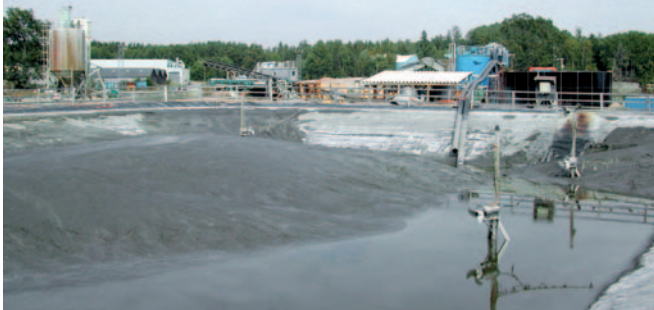
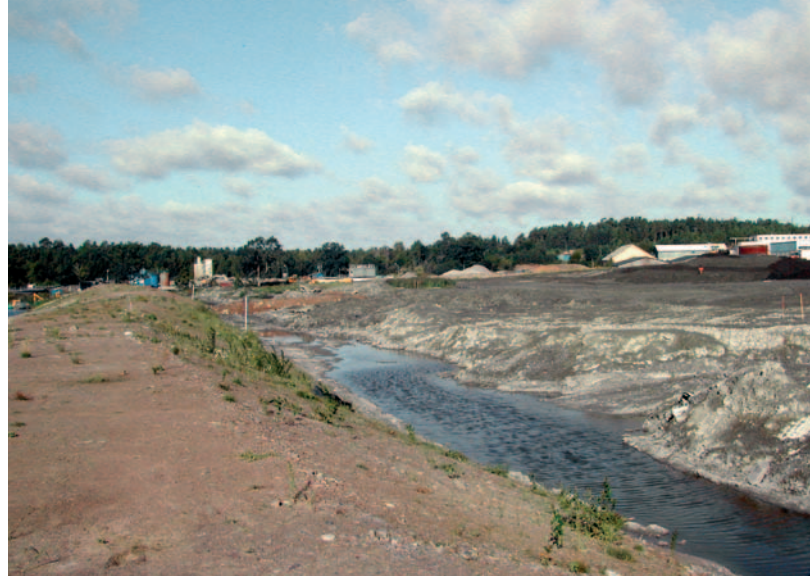
The dredger (above, left) in action in the bay. Below it is a sedimentation tank for the dredging spoil. The picture above shows the dewatered screenings being laid up inside the newly constructed retaining wall.

The Örsörumsviken clean-up was based on removing the uppermost stratum of the bay's benthic sediment. This meant extracting an 0.8 metre thick layer of mud and fibres with a dredger armed with a helical suction nozzle. The dredger was held in position by hawsers

from on shore and its position monitored with GPS satellite navigation equipment. From the dredger the slurry was pumped ashore through a floating pipeline and put through several processing stages, in which it was dewatered with the aid of cyclones and belt filter presses. Finally the water passed through a purifying plant and was assayed before being released back into the bay. The dewatered dredging spoil in turn was mixed

with thickener and cement to a suitable consistency before being driven to its terminal landfill repository inside the newly constructed retaining wall. Admixture of a small proportion of cement created a more stable landfill site with less risk of subsidence.

was something like 500 cu. m. hourly. To maintain a consistently high dredging rate, a sedimentation tank was constructed ashore to receive the spoil whenever the belt filter presses malfunctioned or became overloaded.

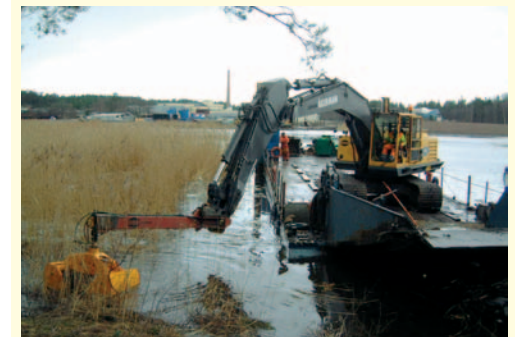
A special shallow-draught boat was used for in-shore operations.

Dredging was not confined to the bottom of the bay. Special shallow-draught machines were used to clear the shores of reeds and contaminated sediment, and a small channel was excavated to reinstate the little island, Karins Holme, off the southern shore of the bay.

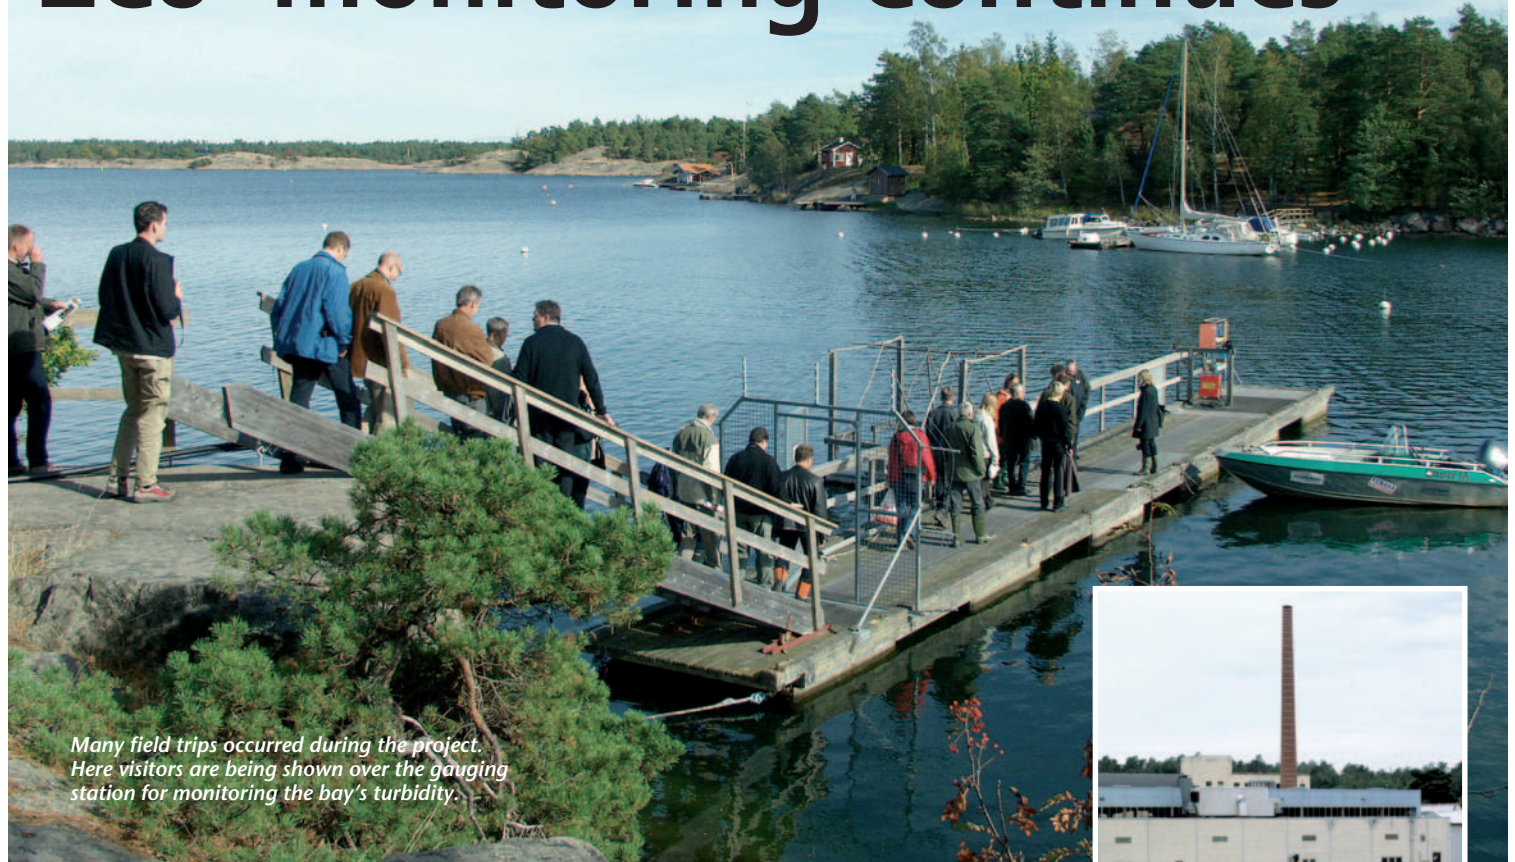
Many field trips occurred during the project. Here visitors are being shown over the gauging station for monitoring the bay's turbidity.

be escaping from the bay. All data were stored at a special gauging station which was always directly accessible from the municipal environment protection office. The station had an in-built warning system which sounded the alarm if dredging was causing excessive turbidity. All the time dredging was in progress, water samples were taken and analysed for toxin content.

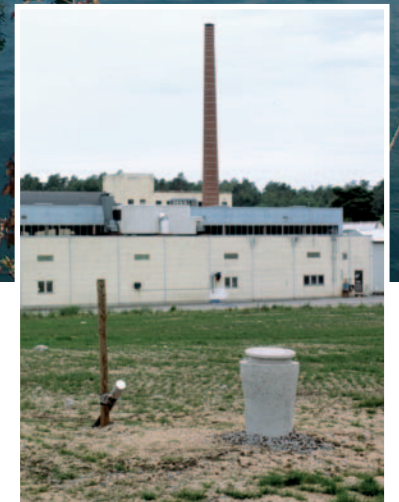
Developments down among the paper fibres can be studied through a well and through a number of pipes in the landfill site. Items for measurement include gaseous emissions and subsidence.

Up on the actual landfill site, where the ecotoxins are now shrouded in bentonite, plastic film, sand and other covering layers, a number of pipes project from the ground. These can be used for studying what is going on down inside the landfill site, whether water is seeping in and whether the gas which will form beneath the cover contains mer-

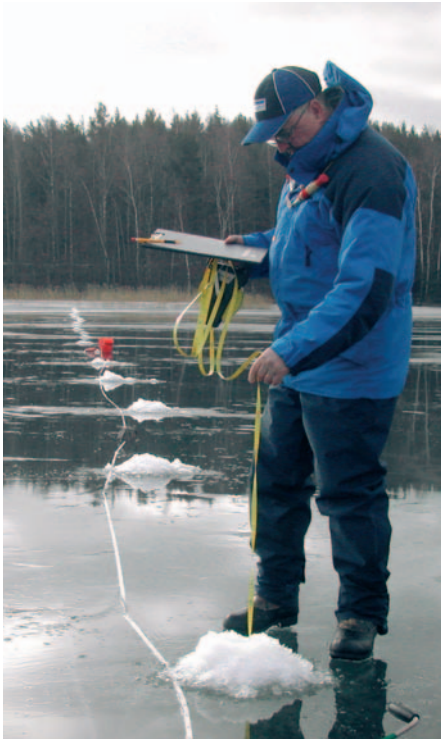
Christer Ramström, sub-project leader for environmental control, sounds the depth of the water after dredging operations in the inner bay.

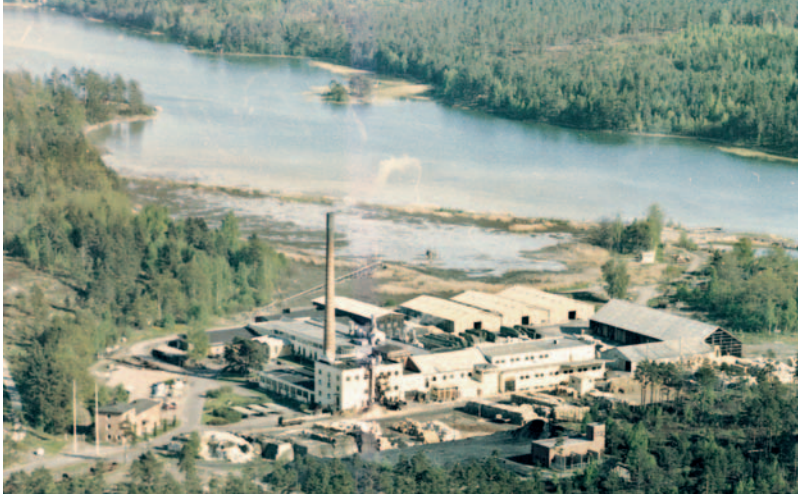
Production at the Westervik papermill started in 1915 and continued until 1980. This air photo, taken in 1963, shows the mill's location on Örserumsviken.

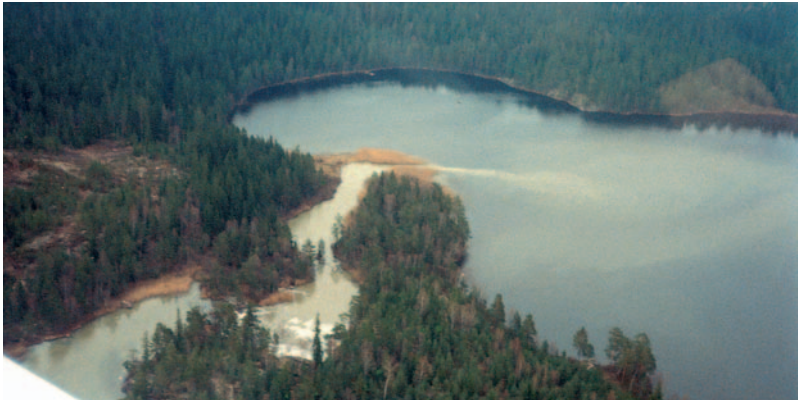
Industrial emissions from the Pauliström papermill have contaminated the Upper and Lower Svartsjöarna lakes in the Municipality of Hultsfred.

papermill, which used mercury in its production processes. As a result, two small lakes downstream, Svartsjöarna ("the Black Lakes"), have received about 250,000 cu. m. mercury-contaminated paper fibre, and the mercury has slowly migrated further to the Emån river.
